Watershed Plan and Preliminary Characterization Report for Friar Branch

City of Chattanooga

Water Quality Program

March 4, 2014

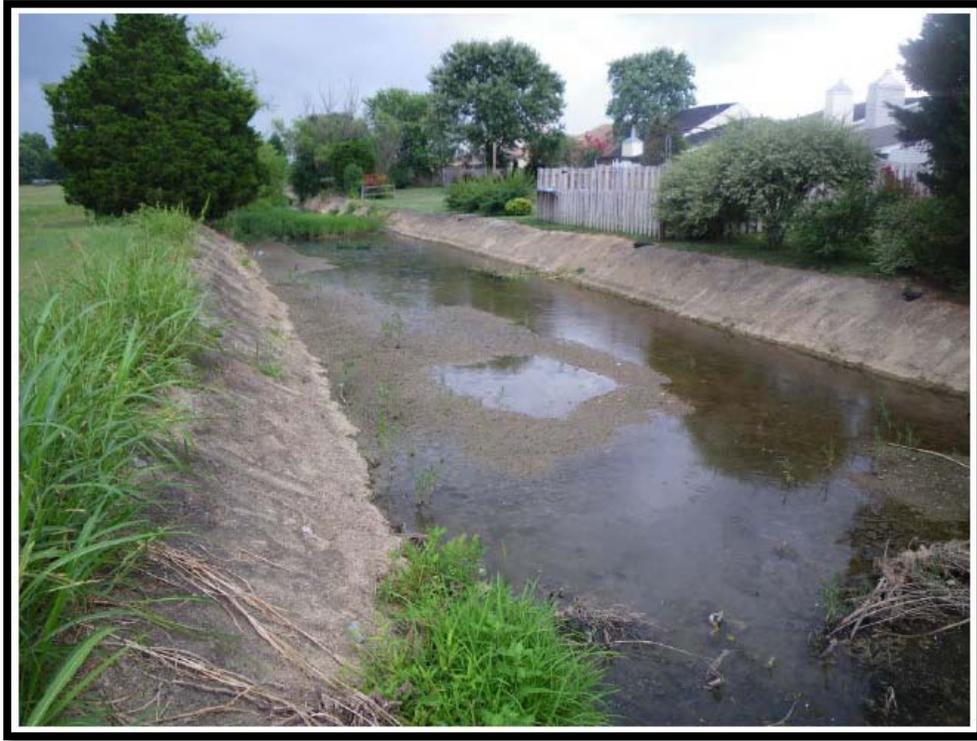
Figure 26. Channelized Stream Before Restoration.

The City’s Water Quality Program completed a stream restoration project in Friar Branch through a partnership with the Tennessee Stream Mitigation Program (TSMP). The project spanned approximately 8,000 linear feet of stream, converting the concrete channels as closely back to a natural meandering stream as possible. The stream was relocated away from residential properties, allowing the creation of 35 acres of riparian conservation easement. Additional benefits of the stream restoration project include the creation of a wildlife refuge, removal of invasive non-native vegetation and planting of native trees and shrubs, improvement of the abundance and diversity of biota, and providing an educational learning opportunity for community members.⁴¹ Just over one third of streams in Friar Branch (approximately seven miles) have been converted from their natural state. Ideally, all streams should remain in their original state or be converted as closely back to their previous, natural state as possible. Potential project sites for future stream restoration projects will be analyzed and selected following this watershed characterization report. Figure 25 depicts an aerial footprint of the Friar Branch Stream Restoration and Figures 26 and 27 show pre and post restoration pictures.

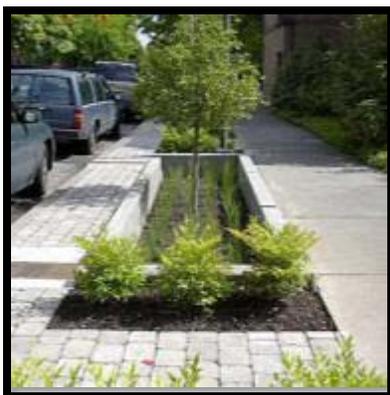
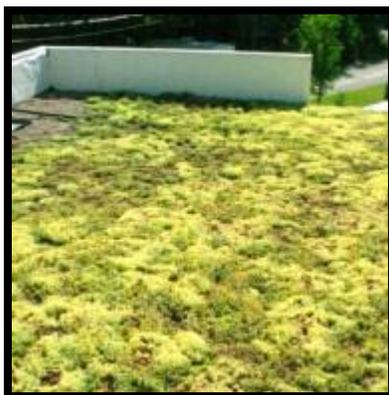
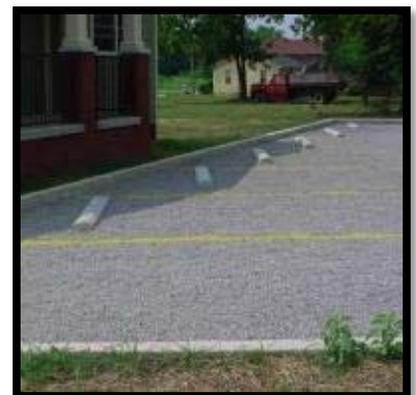
Examples of green infrastructure include rain gardens, pervious pavements, green roofs, and runoff capture and reuse, just to name a few. These techniques promote infiltration back into the ground rather than routing the stormwater to the nearest drain. Many of the green infrastructure devices also improve aesthetics of the area.

Figure 28, 29, and 30. Left: Infiltration Planter ; Middle: Green Roof, The Crash Pad, Chattanooga, TN; Right: Permeable Parking Lot, Jefferson St. Apartment Complex, Chattanooga, TN
